ROCK-SLOPE FAILURE IN PARTS OF THE SCOTTISH HIGHLANDS

GRAHAM HOLMES, B.Sc.

University of Edinburgh

1984

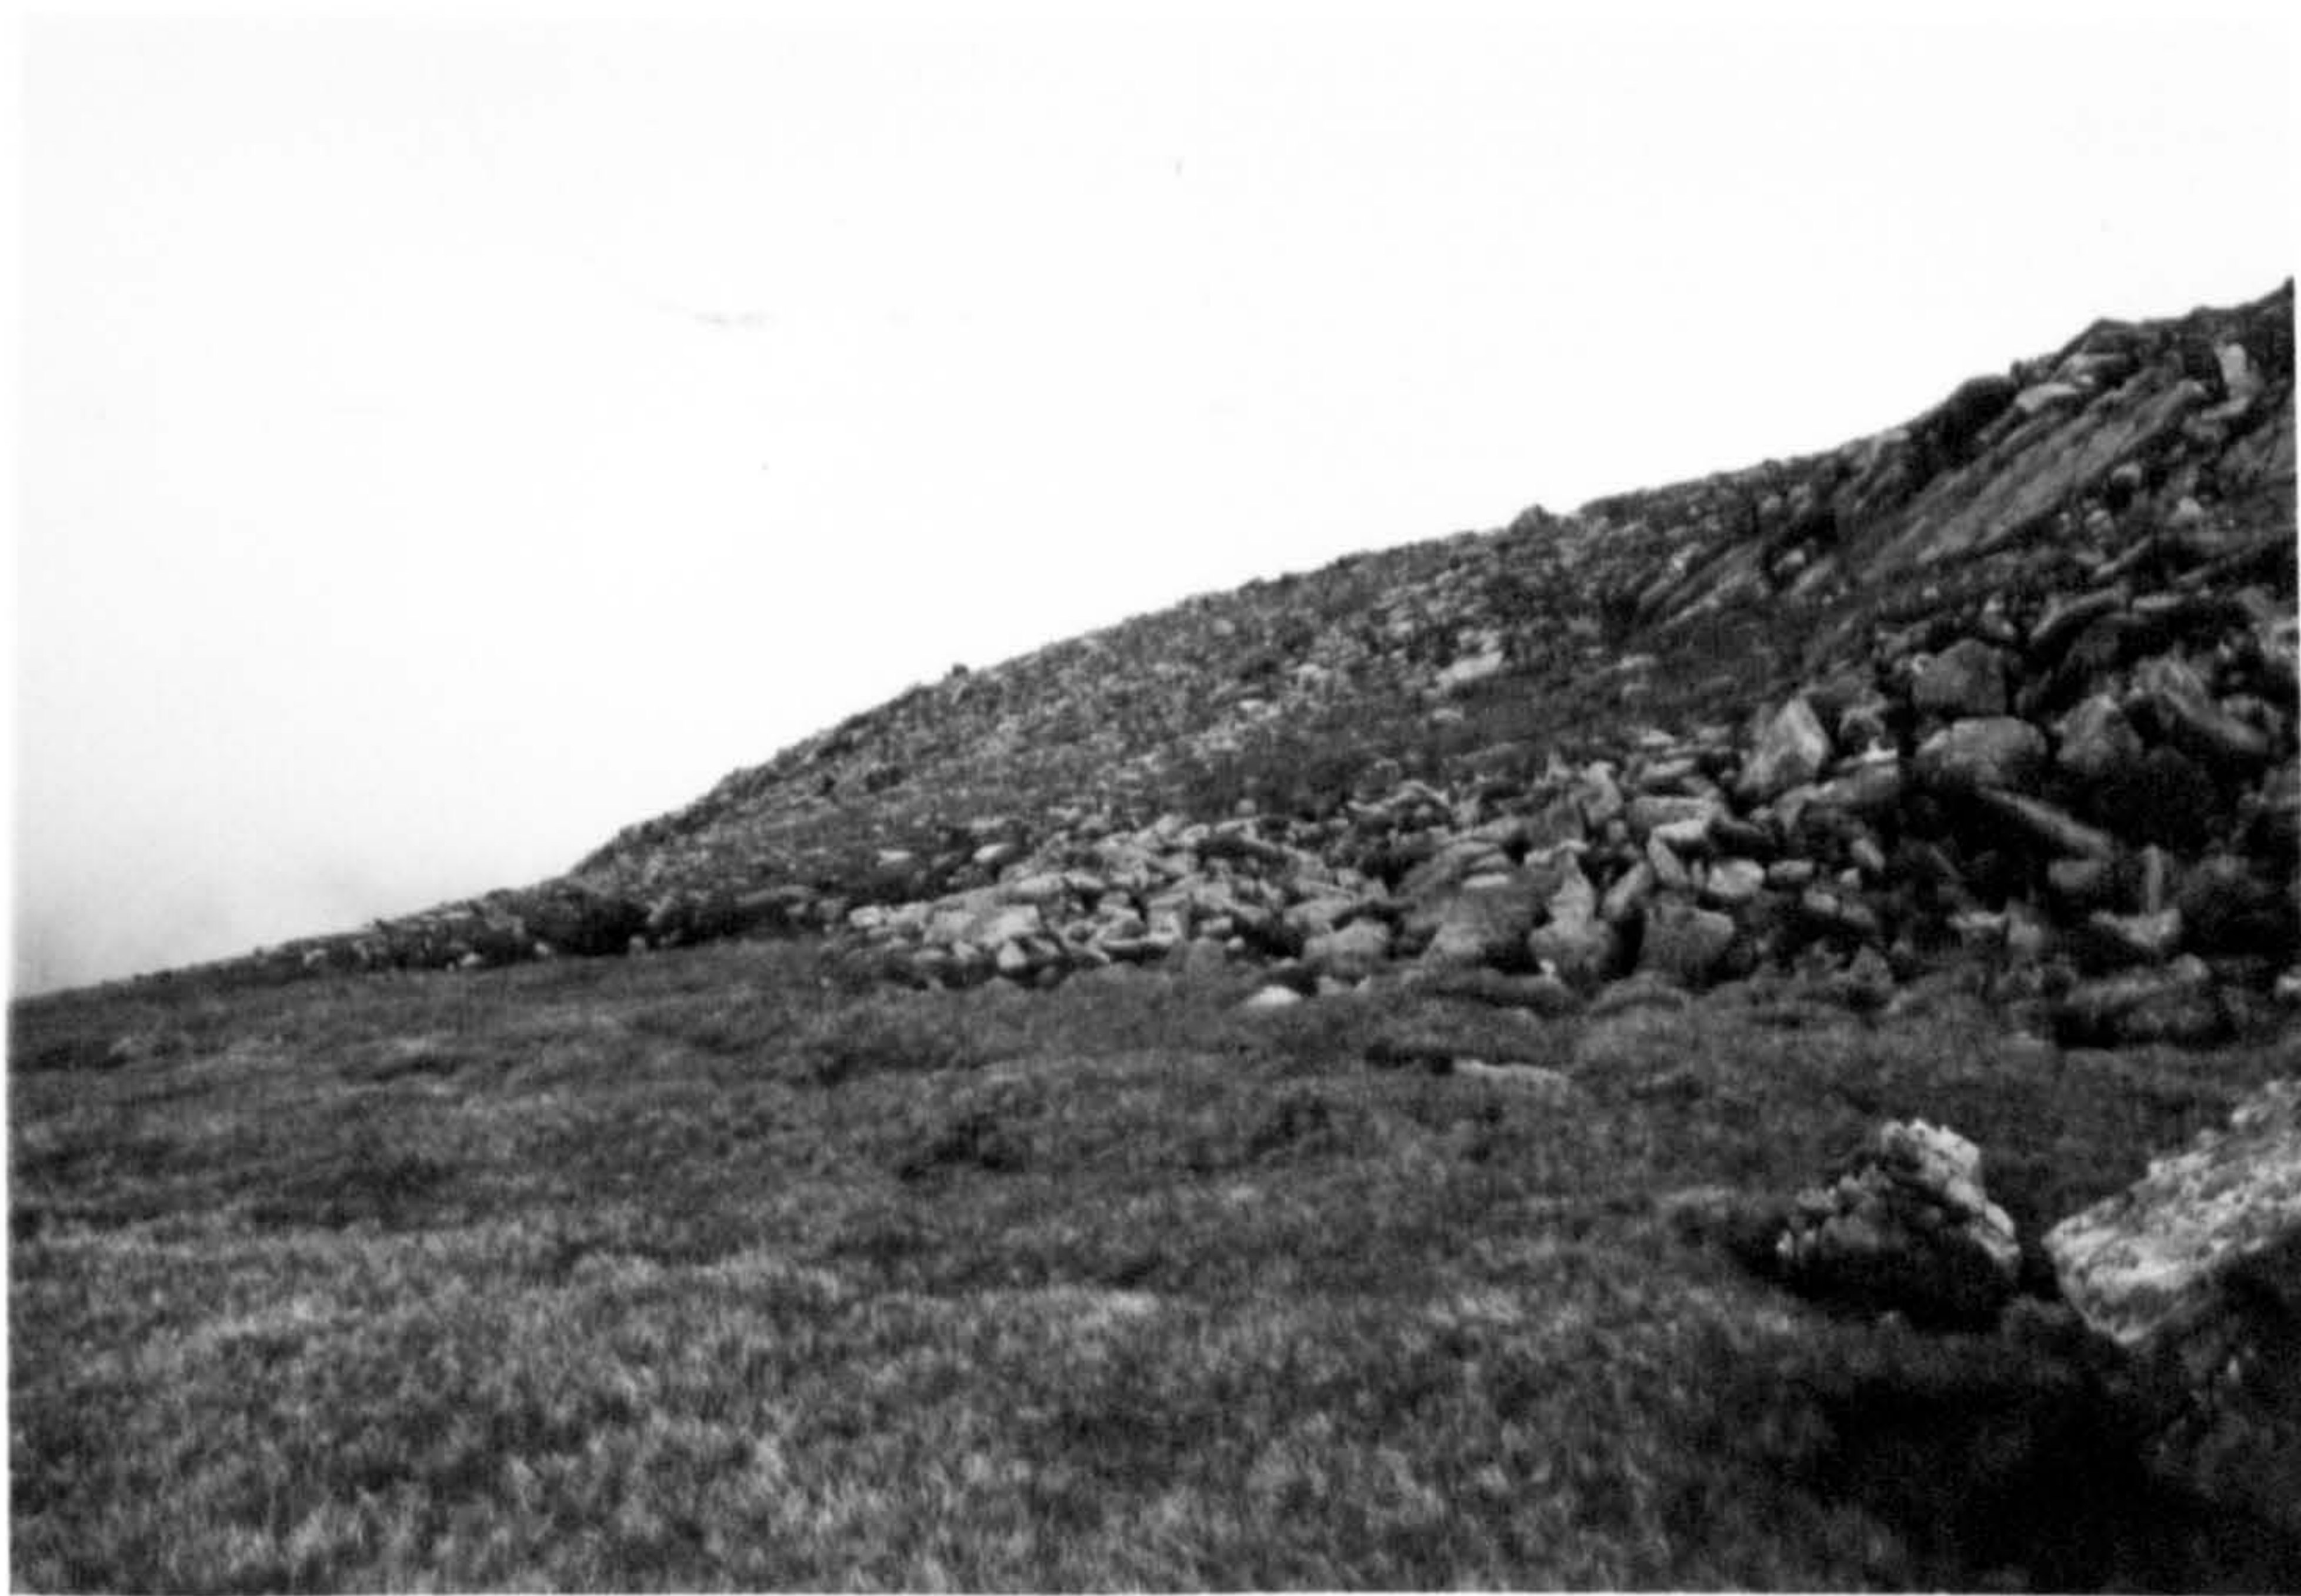
Plate 9.2: Disruption of solifluction lobes by the Sgurr na Lapaich RSF. The rock outcrop (centre-right) is part of the rear-scarp.

- (i) periglacial landforms overlapping RSF features such as failure-scarps and obsequent-scarps (e.g. Plate 9.1);
- (ii) displacement/truncation of periglacial landforms (e.g. Plate 9.2);
- (iii) accumulation of periglacial debris behind RSF features (e.g. Plate 9.3).
